Radiology Corner, Case #14

The Deep Lateral Femoral Notch: A Sign of Anterior Cruciate Ligament Disruption

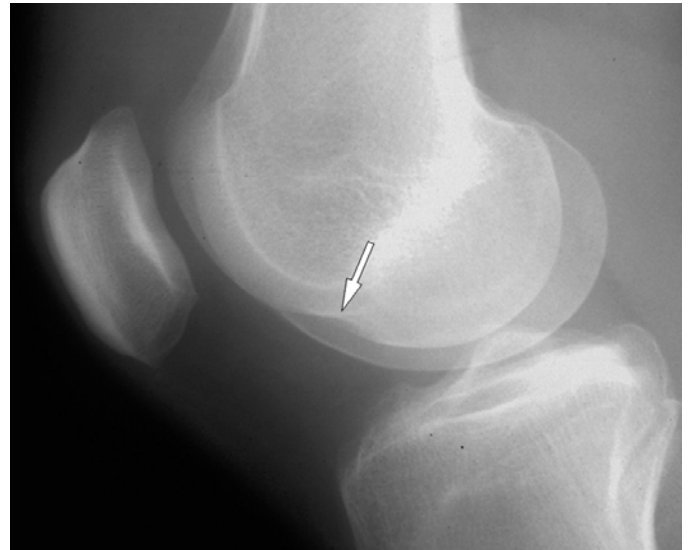
Fig 1. Lateral view of the knee demonstrates a deep lateral femoral sulcus (arrow) with irregularity and asymmetry of the notch.

Lateral radiograph of the knee demonstrates a deep, irregular appearing lateral femoral sulcus, and a small joint effusion, but is otherwise normal (Fig 1). Follow up MR imaging demonstrates marrow edema in the lateral femoral condyle and in the posterior tibial plateau. The lateral femoral sulcus appears deepened and irregular in contour. T2-weighted sagittal image through the region of the intercondylar notch demonstrates complete disruption of the anterior cruciate ligament (Fig 2).

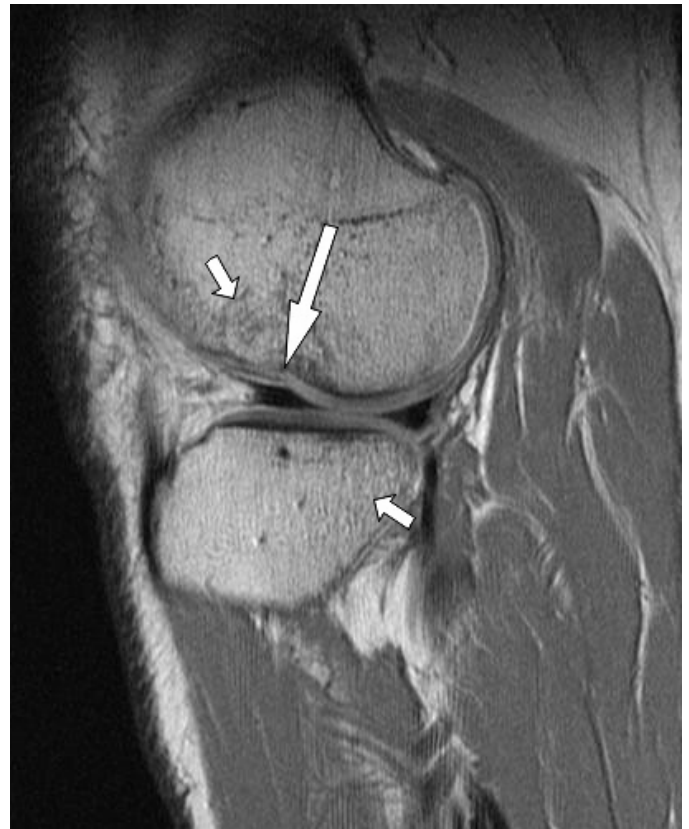
Fig 3. T2-weighted image through the lateral femoral condyle demonstrate a deep irregular appearing lateral femoral sulcus (long arrow). Marrow edema is also noted in the lateral femoral condyle and lateral tibial plateau (short arrows).

MR imaging also demonstrates an irregular appearing deep lateral femoral sulcus and in addition it will demonstrate marrow edema within the lateral femoral condyle and the posterior tibial plateau secondary to the impaction injury (6). This pattern of marrow edema has been referred to as the “pivot shift” marrow edema pattern and is also highly specific for ACL injury. See figures 2, 3 and 4 for examples in our case. MR imaging will demonstrate the ACL disruption along with associated injuries of internal derangement to include meniscal tear, chondral injury and collateral ligament tear.
